AJNR Am J Neuroradiol 1992, 13 (1) 301-302
<http://www.ajnr.org/content/13/1/301.citation>

Buffing Up MR Images

Summary: The authors describe an innovative approach to buffing up MR images.

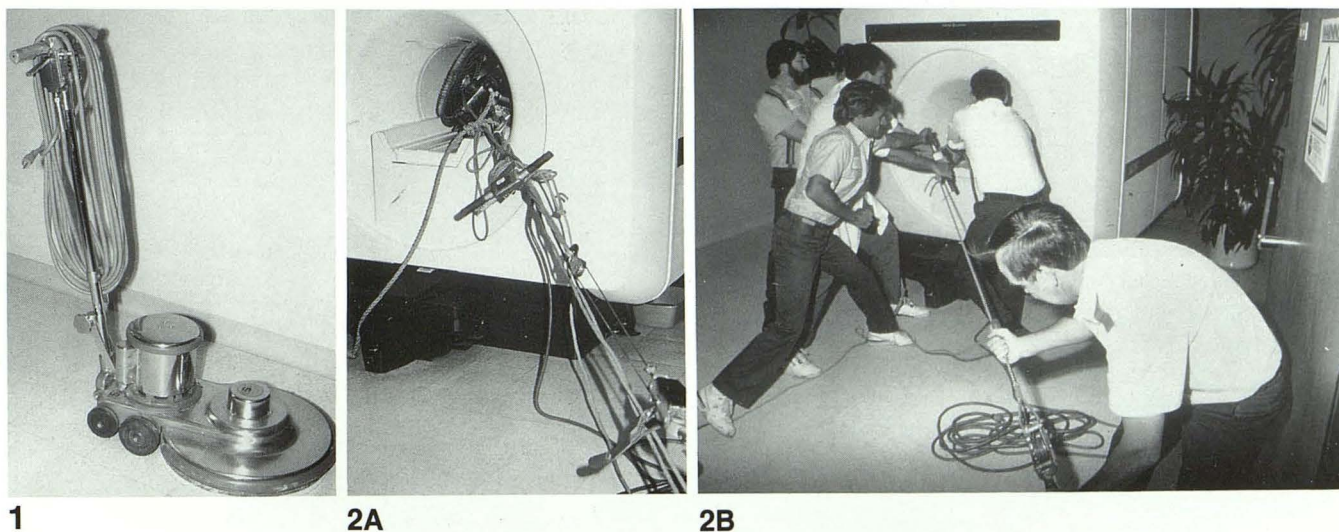
A model SSS 1040 Ultra High Speed floor wax buffer (Fig. 1) has been used at our facility for several years to clean the floors of the MR and MEG (magnetic encephalography) building. The threshold of the scanning room housing a GE Signa 1.5 T (General Electric, Milwaukee, WI) is clearly indicated, with a warning of the potential danger of the high magnetic field strength. Maintenance personnel are routinely informed of the risk of crossing this threshold with ferromagnetic materials. This knowledge notwithstanding, on the eve of May 10, 1990, an experienced member of the maintenance team noticed a blemish on the floor that he described as a macular taint having serpiginous borders and lying in propinquity to the threshold of the room. Extirpation of the blemish was attempted.

Fig. 1. The model SSS 1040 Ultra High Speed floor wax buffer.

Fig. 2. A and B, Attempted extraction of the buffer from the magnet bore.

Upon crossing the threshold of the magnet room, the floor buffer was pulled from the grasp of the maintenance employee and propelled to a final resting place within the bore of the magnet. Attempts to extract the buffer from the magnet with a block and tackle were unsuccessful (Fig. 2). After incrementally ramping down the magnetic field strength by using the shim power supply, the floor buffer was successfully removed from the bore of the magnet.

It is important to emphasize that all patients must be removed from the scanner prior to installing the buffer, and that care should be taken not to stand between the floor buffer and the magnet while crossing the threshold of the scanning room. Failure to heed this caveat may be hazardous.
