AJNR Am J Neuroradiol published online 2 July 2020 http://www.ajnr.org/content/early/2020/07/02/ajnr.A6639

MRI Head Coil Malfunction Producing Artifacts Mimicking Malformation of Cortical Development in Pediatric Epilepsy Work-Up

[●]N. Kashani, [●]N. Khan, [●]J.M. Ospel, and [●]X.-C. Wei

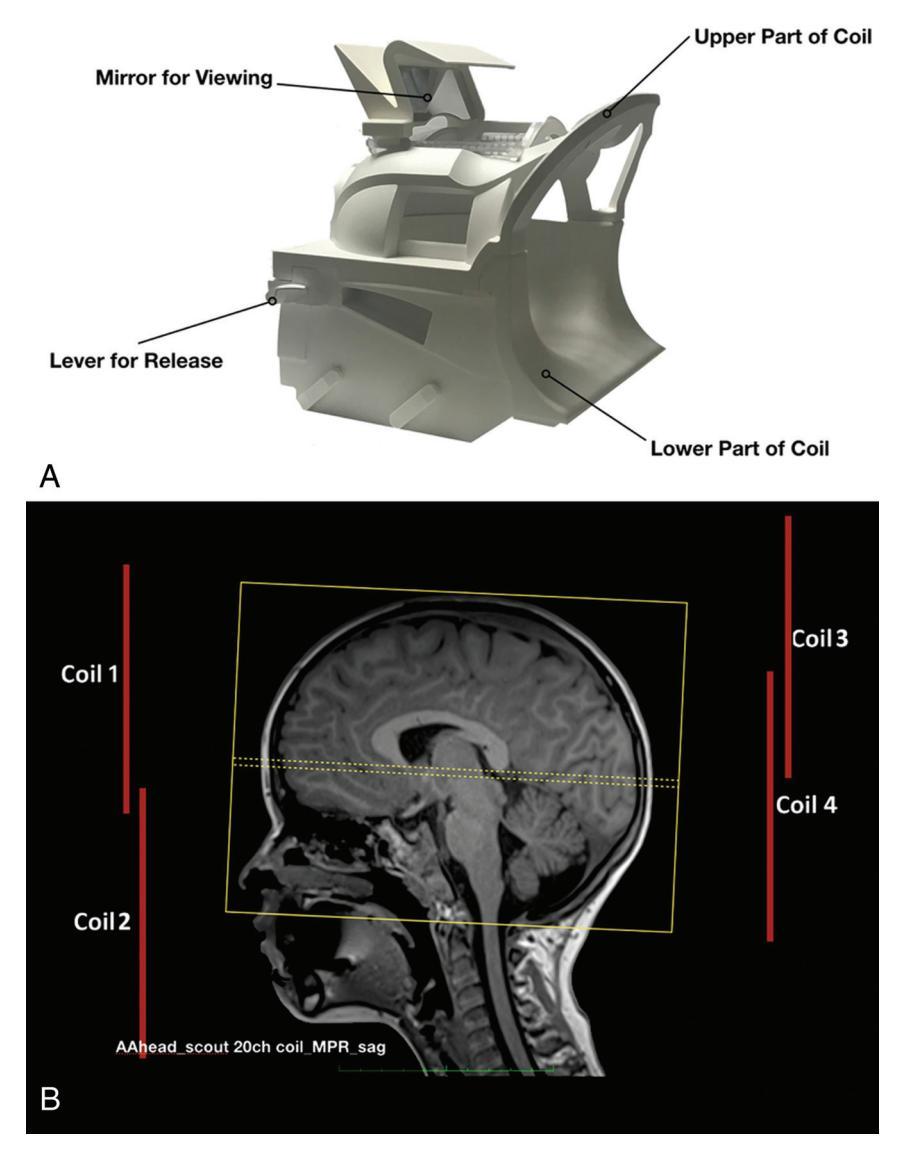
Recently, we encountered a series of incidents in which the 2 anterior groups of coil elements were inadvertently disconnected from the MR imaging system during patient scanning. This malfunction could not be eliminated by the scanner operator, neither could it be identified in the DICOM header. The resulting artifact occurred exclusively anteriorly and bilaterally and can be mistaken for a cortical abnormality. In the first incident, the scan was interpreted by neuroradiologists as possible polymicrogyria until a repeat scan 3 weeks later showed a normal cerebral cortex, whereas in the following incidents, the neuroradiologists recognized the artifact, thereby avoiding misdiagnosis.

FIG 1. Picture of a typical multichannel MR head coil (A) shows the positions of the multiple coil elements. A modified screenshot from the operator console of the system (β) shows indicators of the positions of the 4 groups of a 20-channel head coil. *Red bars* show the position of the individual groups of head coil elements. The coils 1 and 2 are anterior coils, while the coils 3 and 4 are posterior coils.

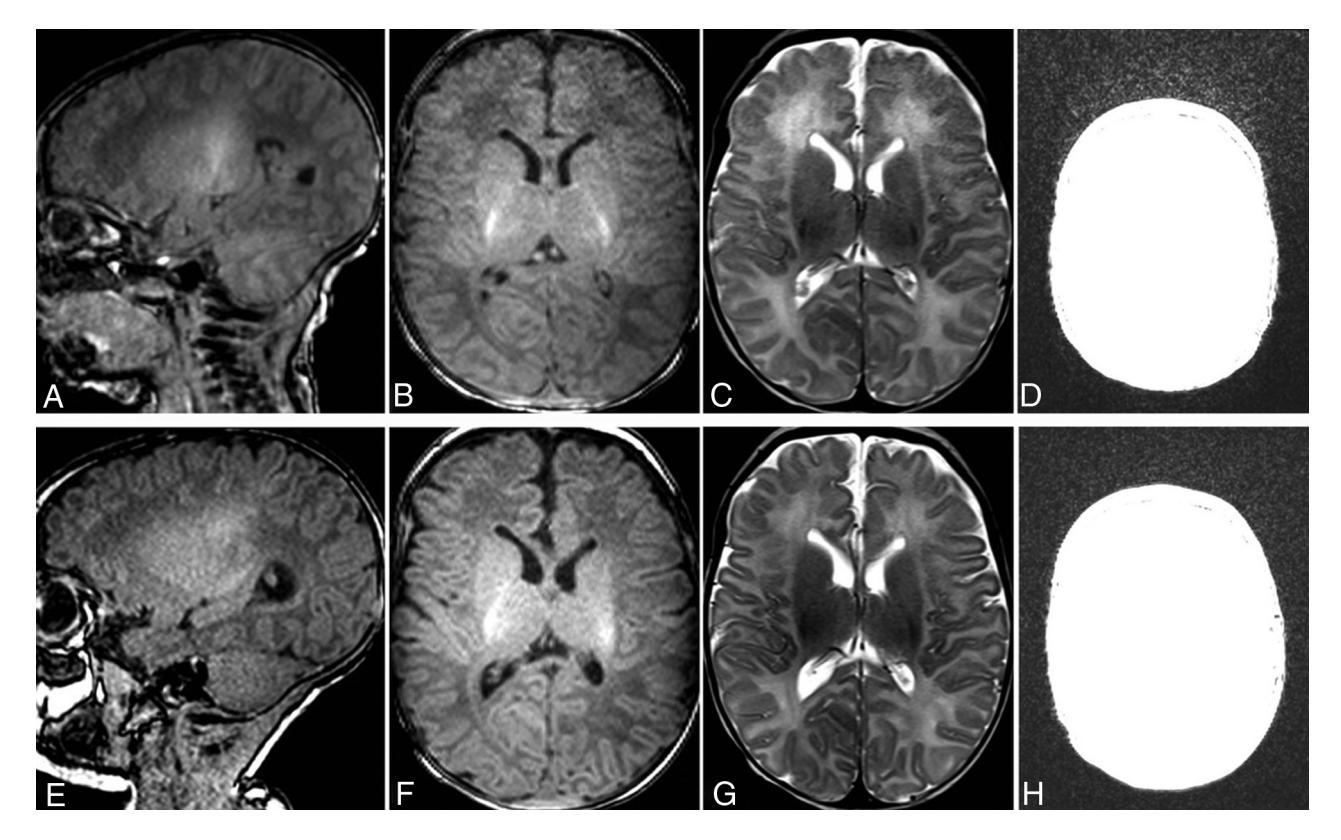
Case 1. A 2-week-old term male neonate was admitted with suspected bacterial meningitis. A brain MR imaging was requested to rule out any complications from meningitis. The MR imaging was performed (3T Magnetom Vida; Siemens), including 3D MPRAGE T1WI, axial and coronal FSE T2WI, DWI, gradient-echo T2*-weighted images, TOF-MRA, and phase-contrast MRV. A 20-channel head coil was used. A small amount of pus in the trigones of both lateral ventricles was identified, and bilateral frontal cerebral cortex surfaces as well as cortical white matter junctions appeared irregular, while their signal intensities were normal on all sequences. The findings were interpreted as possible polymicrogyria (Fig 2A, -C).

Repeat MR imaging was performed 20 days later on the same scanner with identical sequences and coils. The frontal cerebral cortex now appeared normal, and the previously seen irregular outer and inner surfaces of the frontal cortex were no longer present (Fig $2E_s$ -G). Therefore, a coil malfunction was suspected. Scanning parameters of the first scan were then reviewed, and it was noted that the anterior 2 groups of the coil elements were "off."

When multichannel head coils are used, the proximity of the coil elements to the surface of the patient (and ROI) is critical because the radiofrequency coil depends on the near field to couple energy from the spin system to the coil elements. When the radiofrequency coil is away from the ROI, reduced coupling to the spin system and poor signal-to-noise ratio occur.⁴ When the anterior coil elements malfunction, the frontal brain structures are relatively remote from the functioning posterior receiver coil elements. Therefore, the anterior portion of the MR images will have a much lower signal-to-noise ratio, and the frontal lobes of

FIG 2. MR imaging of the brain of case 1 at presentation (A–D) and 20 days later (E–H). On the sagittal and axial TIWI (A and B) and the axial T2WI (C) of the first scan, the cerebral cortices of the bilateral frontal lobes show apparent irregular surfaces and gray-white matter junctions. Because the irregularity was observed on both TIWI and T2WI and the posterior cerebral cortices have rather smooth surfaces, without knowing the possibility of coil malfunction, we interpreted the findings as possible polymicrogyria. On the sagittal and axial TIWI (E and F) and the axial T2WI (G) of the follow-up scan obtained only 20 days later, the irregularity is no longer present, suggesting that the irregular appearance of the cortex seen on the first scan is artifactual rather than pathologic. When the window setting was adjusted to evaluate the background noise of the axial TIWI of the first (D) and follow-up (H) scan, it is obvious that the first scan has pronounced background noise in the frontal part of the image.

the brain will show apparent irregular surfaces and an irregular gray-white matter junction. While the malfunction of a coil may produce substantial artifacts on 1.5T MR imaging scanners, the artifacts may be considerably more subtle on 3T MR imaging scanners. On high-field MR imaging, because of the overall high signal-to-noise ratio, the drop of the SNR may not be severe enough to alarm the MR imaging technologist about possible hardware malfunction.

The apparent cortical irregularity simulates malformation of cortical development. Indeed, we misinterpreted this artifact as a polymicrogyria in our first patient. Fortunately, the patient had a repeat MR imaging not long after, and no harm was done to the patient. MR imaging technologists and radiologists should be vigilant for this type of artifact. Unlike other MR imaging artifacts, this type of artifact persists and appears on all the sequences of any acquisition plane if not recognized. The radiologist should not conclude that the apparent cortical irregularity is not artifactual because the cortical irregularity can be seen on all sequences. Bilateral and symmetric abnormalities should raise suspicion for the presence of such an artifact. It can be easily confirmed by adjusting the window setting of the images and visualization of a pronounced frontal background noise (Fig 2D and On-line Figs 1B and 2B). The artifact can be corrected by re-plugging the head coil. Of note, our case series consists of only 3 patients, and the
