## **Black Holes on MR Images of the Brain of Patients with Björk-Shiley Heart Valves: Additional Observation in Three Cases**

*AJNR Am J Neuroradiol* 2003, 24 (3) 512-514  
<http://www.ajnr.org/content/24/3/512>

## Case Report

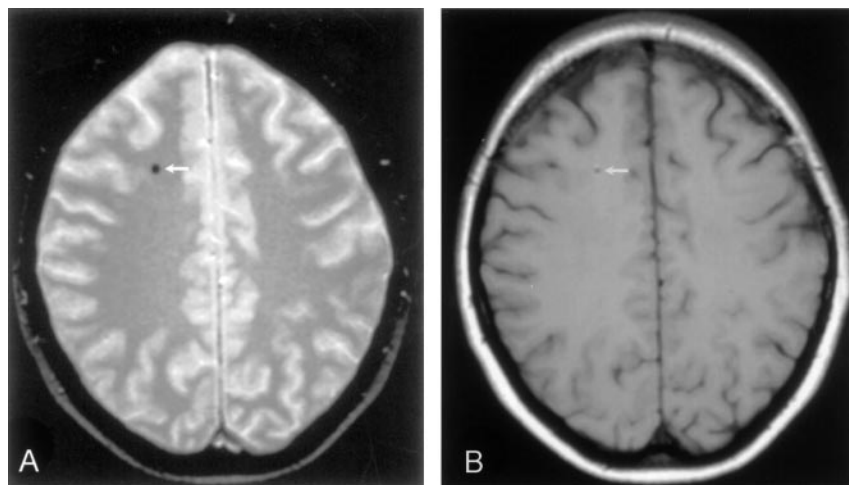
FIG 1. Patient 2.

A, Axial view T2\*-weighted gradient-echo image (710/27.6/2 [TR/TE/number of excitations]) shows a black hole (arrow). Repeat images obtained after 1 year appeared unchanged, with no increase in number or size of black holes (not shown).

B, Corresponding axial view T2-weighted spin-echo image (1380/60/2) shows the same black hole with a typical white halo (arrow).

The substances that could be responsible for these susceptibility artifacts can be divided approximately into four different groups: air, calcium, microhemorrhages, and foreign metallic particles. Air can be ruled out because of expected resolution over time, which we did not observe on the second set of images obtained for patient 2 after 1 year. As for calcium deposits, these have slightly distinct appearances on MR images and lack the white halo, which was clearly visible on the T2-weighted spin-echo sequence of pa-

tient 2 (Fig 1B). In addition, the blooming of signal intensity loss on the T2\*-weighted gradient-echo sequence is not observed with calcium deposits.

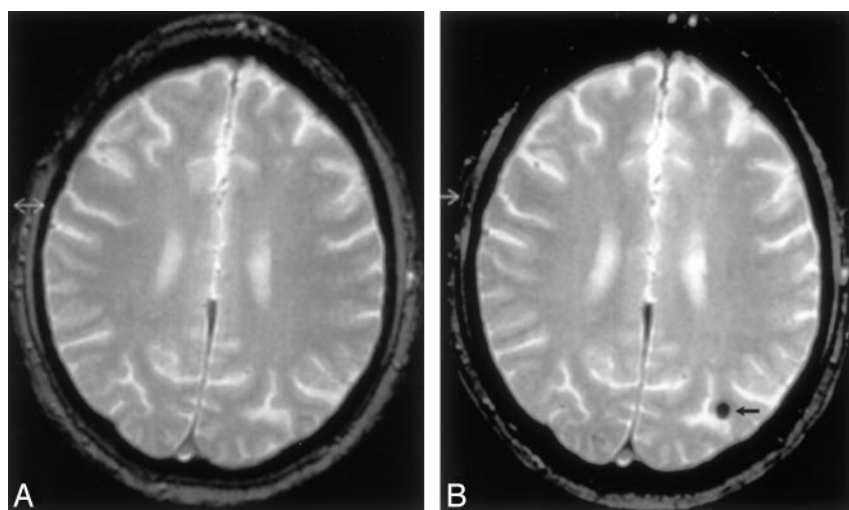
FIG 2. Patient 3.

A, Axial view T2\*-weighted gradient-echo image (710/27.6/2), obtained 1 week before double valve replacement, shows no apparent abnormalities.

B, Axial view T2\*-weighted gradient-echo image (710/27.6/2), obtained 5 months after successful double valve replacement, shows one of the two large black holes (arrow).

Interestingly enough, the images of patient 3 showed artifacts after the Björk-Shiley convexo-concave valve explantation and not before. When valve wear or damage is considered for this patient, one would expect that the "exposure time" of the valve to the circulation was sufficient to cause some artifacts. In addition, no cracks or fractures were discovered with scanning electron microscopy research after valve removal, although common valve wear was obvious. Based on the postoperative changes seen on the MR images, it seems that surgery played a more important role in the formation of these artifacts. This could also be the case for the first two patients for whom we did not have MR images of the brain before explantation. If intensive cardiac surgery were to induce these artifacts, however (ie, by means of surgical instrumentation or cardiopulmonary bypass machines), one would expect to observe it more frequently in daily practice. This may be explained in part by considering that patients with prosthetic heart valves often are unjustly withheld from MR imaging investigation because of fear of valve failure being induced by the magnetic field (14). Moody et al (15) have reported extensively on microembolic phenomena associated with cardiopulmonary bypass, combining clinical presentations and histochemical staining. Unfortunately, in our cases, no pathologic or histochemical evidence is available. In general, detrimental effects on the brain after cardiopulmonary bypass
