AJNR Am J Neuroradiol 2003, 24 (8) 1697-1706 http://www.ajnr.org/content/24/8/1697

- Technical Note

Percutaneous Vertebroplasty: Complication Avoidance and Technique Optimization

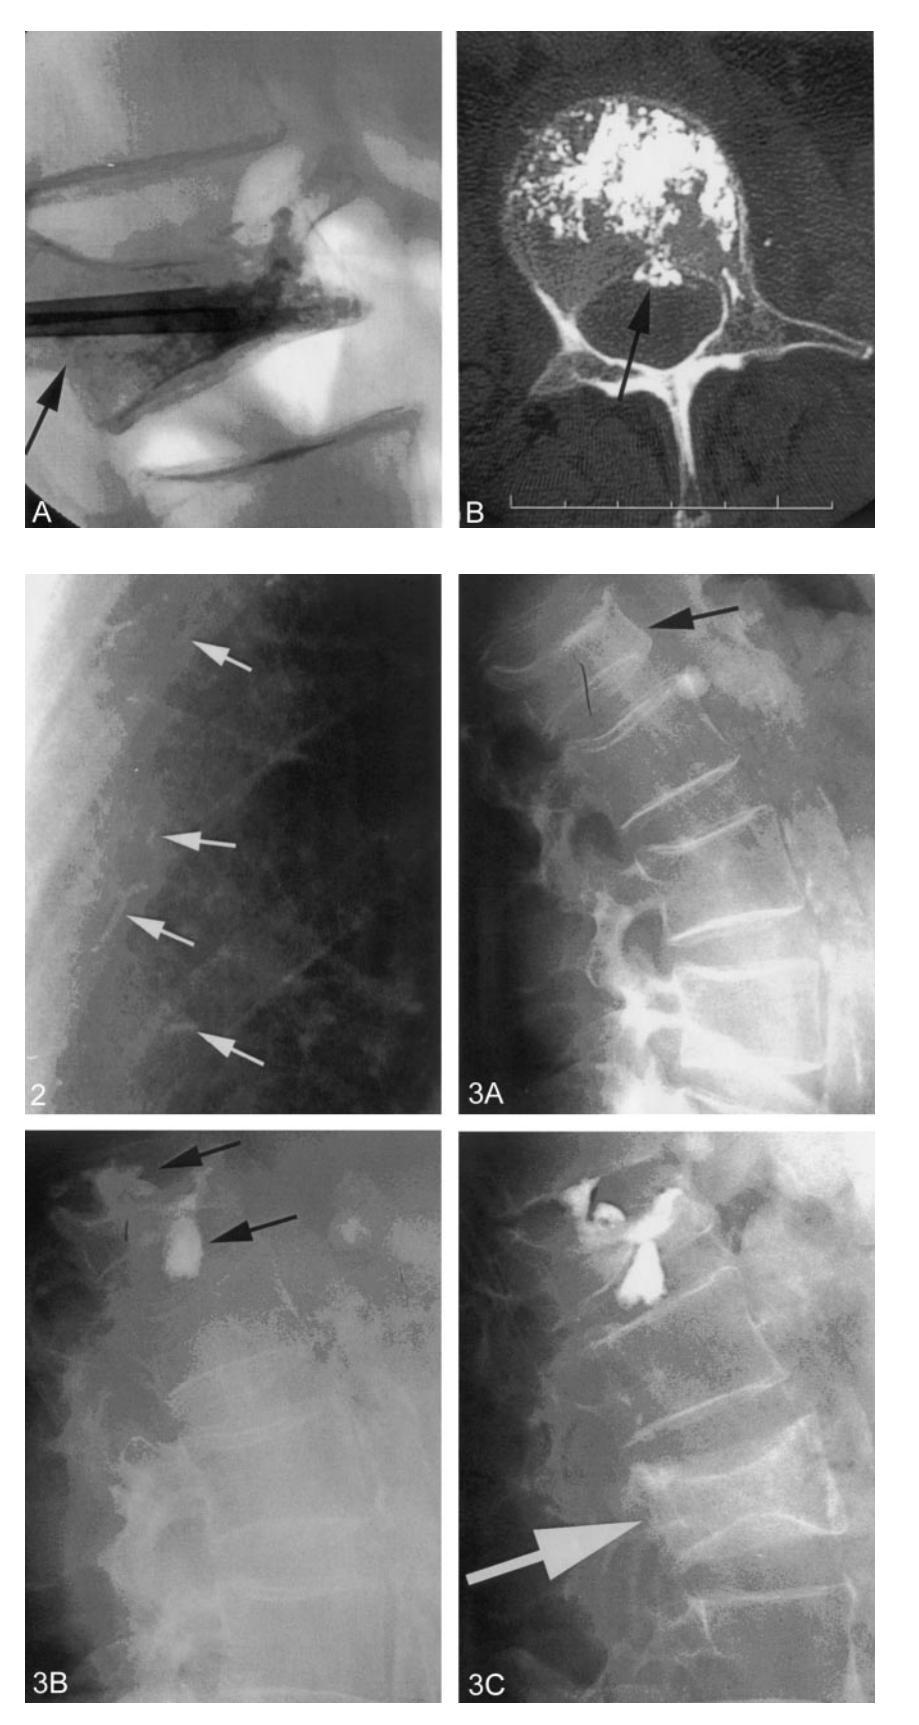
Fig 1. *A*, Lateral radiograph during vertebroplasty showing cement extending to the posterior vertebral margin (*black arrow*).

B, Post-PV CT scan demonstrates a small leak into the epidural venous plexus (*black arrow*). This leak was asymptomatic.

Fig 2. Portion of a chest radiograph after PV showing small radiopaque cement emboli (*white arrows*) in peripheral pulmonary vessels. This patient had no pulmonary symptoms.

Fig 3. *A*, Lateral radiograph of the spine showing a moderately compressed vertebra (*black arrow*).

B, Postvertebroplasty, there are large leaks of cement (*black arrows*) into the adjacent disk spaces.

C, Six months later, the patient returned with a second fracture (*white arrow*). This fracture is not an adjacent level. Adjacent levels did not fracture despite the large disk leaks.

are not of consequence if small. There has been speculation that large disk leaks may predispose the adjacent vertebra to collapse. This has not been proved, however, and I have not seen this effect in my practice. Figure 3 demonstrates a subsequent fracture that occurred away from a large disk leak. If a cement leak into the disk predisposes to an adjacent fracture, the statistical confirmation will be hard to obtain, because adjacent-level fractures after PV are known to occur without leak (5, 6).

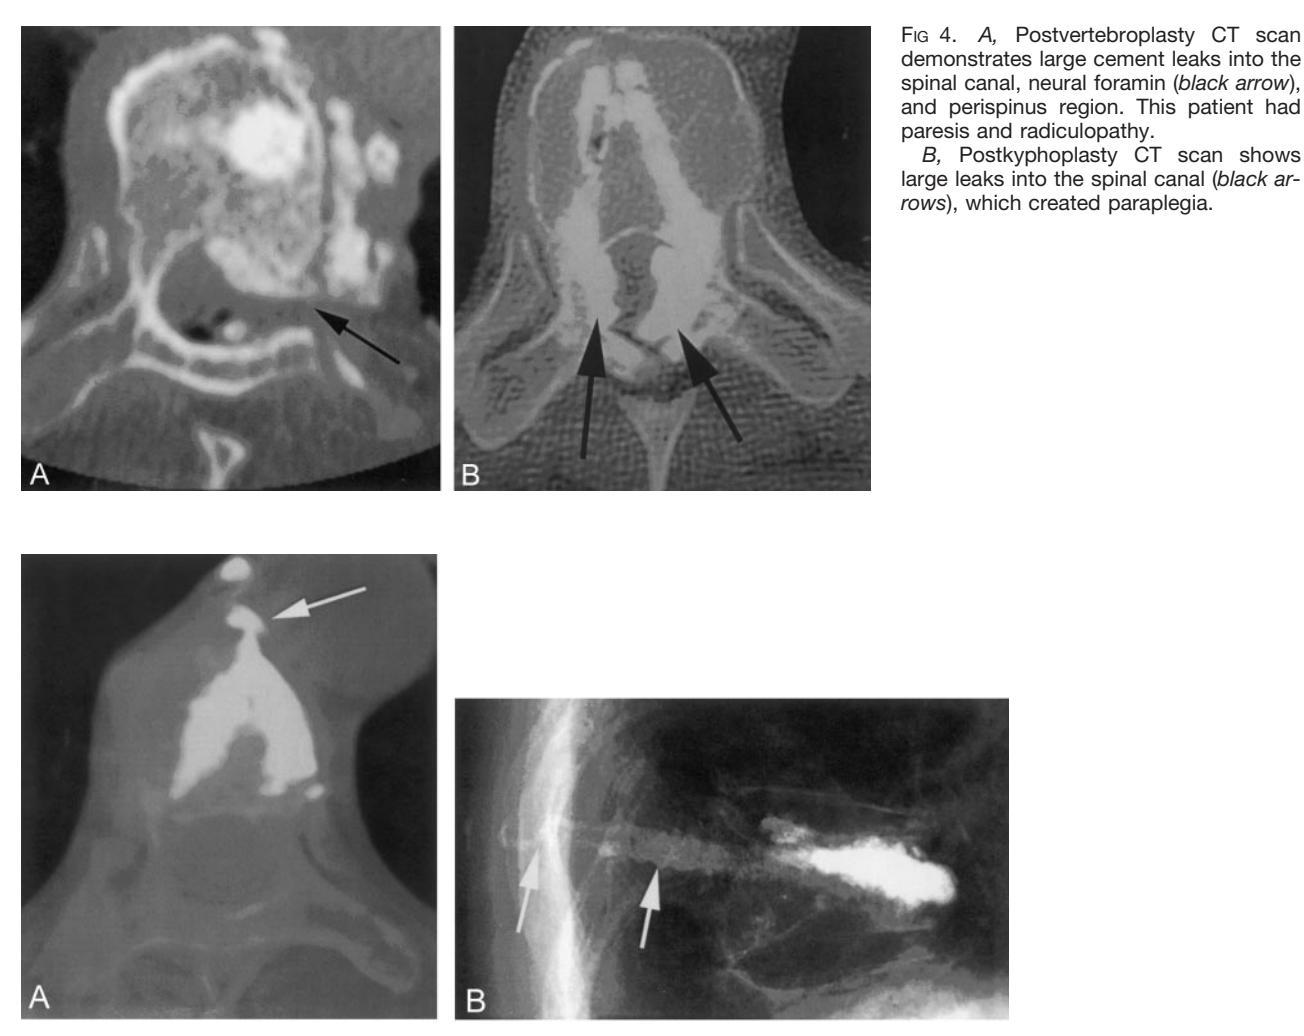
Fig 5. *A*, Postkyphoplasty CT scan. The lateral wall was disrupted by the balloon inflation, and a large cement leak into the mediastinum resulted (*white arrow*). For weeks following the procedure, this patient had severe, persistent pain.

B, Lateral radiography after vertebroplasty with a slow-set PMMA. The needles were withdrawn and the cement was still liquid enough to flow into the needle tracts and into the soft tissue (*white arrows*). This created local discomfort to pressure.

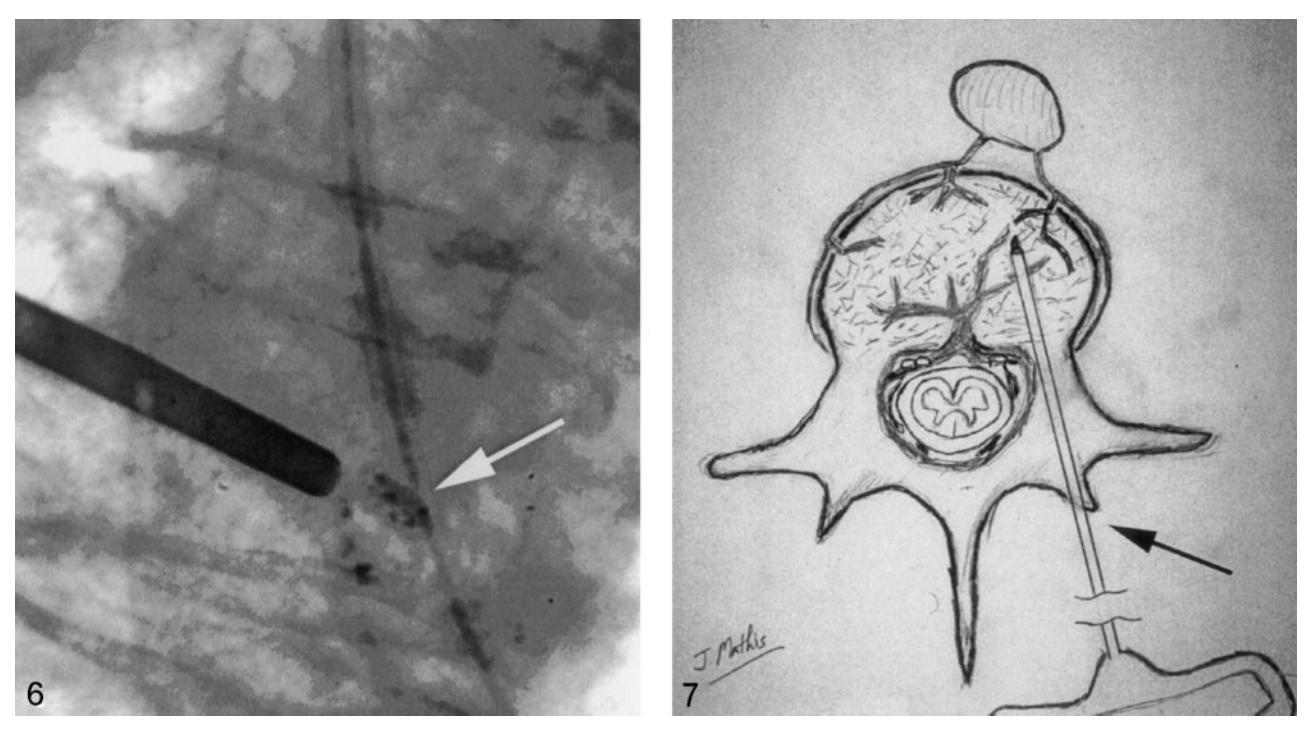
Fig 6. Radiograph showing appropriately opacified cement (white arrow) that can be easily seen even in very small quantities.

Fig 7. Drawing depicting the needle entry site into the bone (*black arrow*) for a transpedicular approach. Following removal of the needle, local pressure allows one to easily achieve hemostasis in this situation.

Good cement opacification is also crucial to being able to recognize an early cement leak while it is small. Because there is presently no cement specifically made and optimized for PV in the United States, the addition of an opacification agent is required. In the United States, the opacification agent of choice has been barium sulfate. Sterile barium sulfate is added to bring the barium quantity to 30% by weight (8, 9). This allows one to see adequately even small quantities of cement during fluoroscopy (Fig 6).

The transpedicular approach places the needle entry site into the bone along the dorsal aspect of the vertebral posterior element and in a position easily compressed with local skin pressure (Fig 7). This approach, therefore, offers the greatest margin of safety for being able to control local bleeding easily. Parapedicular and posterior-lateral approaches place the needle entry site more laterally and may make hemostasis with local pressure more problematic.

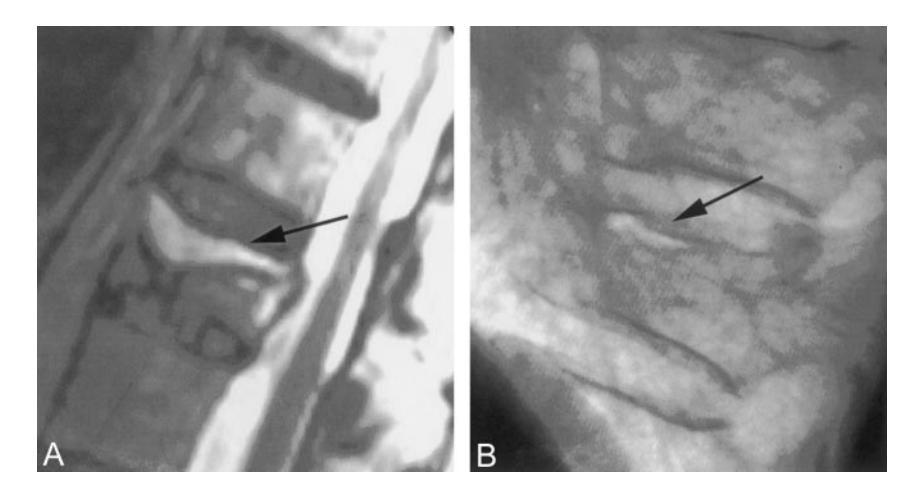
Fig 8. *A*, T2 sagittal MR imaging demonstrating a high signal intensity collection (*black arrow*) below the superior endplate of this compressed vertebra. This represents a fluid-filled vertebral cleft.

B, Lateral radiograph showing an airfilled cleft (*black arrow*) in a compression fracture.

Clefts and Cavities.—Cavities in the vertebral body can form as a result of compression trauma. These areas are often seen on MR imaging (T2 weighting) as bright bands below the endplate (Fig 8A; 15, 16). These cavities are fluid-filled spaces that probably result from local rebound of the endplate following compression, leaving a space that ultimately fills with air or fluid. When filled with air, this cavity (or cleft) can be seen fluoroscopically or radiographically (Fig 8B). These clefts may be an indication of nonunion of the bone and can demonstrate movement of the bone with change in patient position or respiration (17). This motion can be responsible for persistent (or permanent) pain lasting many months after the actual fracture. To treat these fractures adequately, the cavity must be completely filled with bone cement. Fortunately, this is usually easy to accomplish, because the cement often seeks the cavity preferentially, regardless of position of the needle tip (Fig 9). This pathologic situation also presents an excellent opportunity to achieve some vertebral height restoration during the PV procedure (Fig 10; 18); however, the important point here is that the cleft or cavity must be sufficiently filled to prevent future motion. With this accomplished, these cavities are dependably good responders for pain relief after PV.

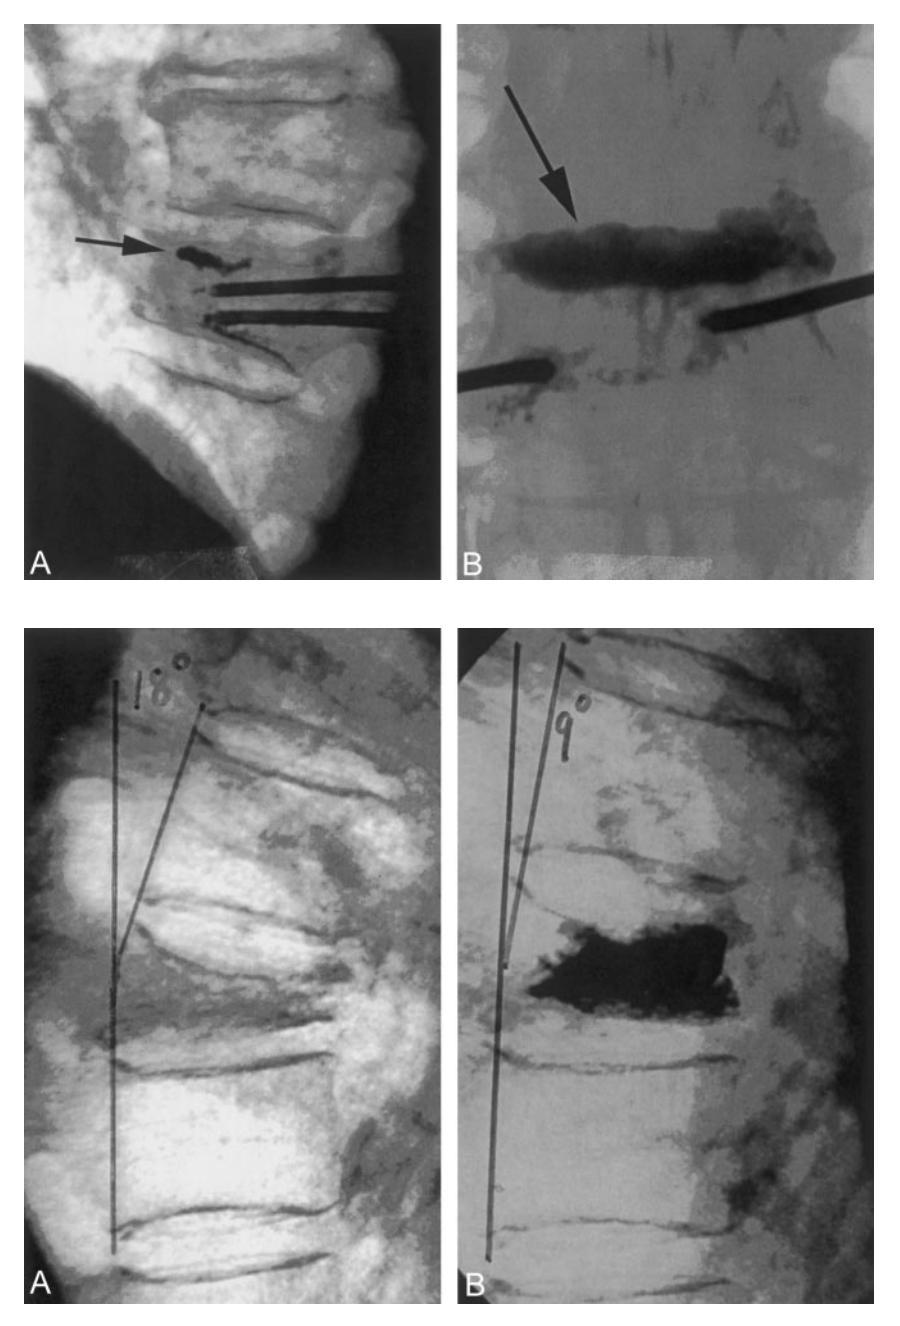
B, Anterioposterior view of the same vertebra at completion of the vertebroplasty. The cleft (*black arrow*) has been completely filled with cement. Relatively little cement has been deposited into the rest of the vertebra. This typically results in good pain relief without the need for repeat filling of the noncleft portion of the vertebra.

Fig 10. *A*, Lateral radiograph demonstrating marked compression of a lower thoracic vertebra. Note the 18° of kyphosis before vertebroplasty.

B, With mild extension of the body, some height was restored to vertebra during vertebroplasty. This postvertebroplasty image shows that the kyphosis has been reduced to 9°.

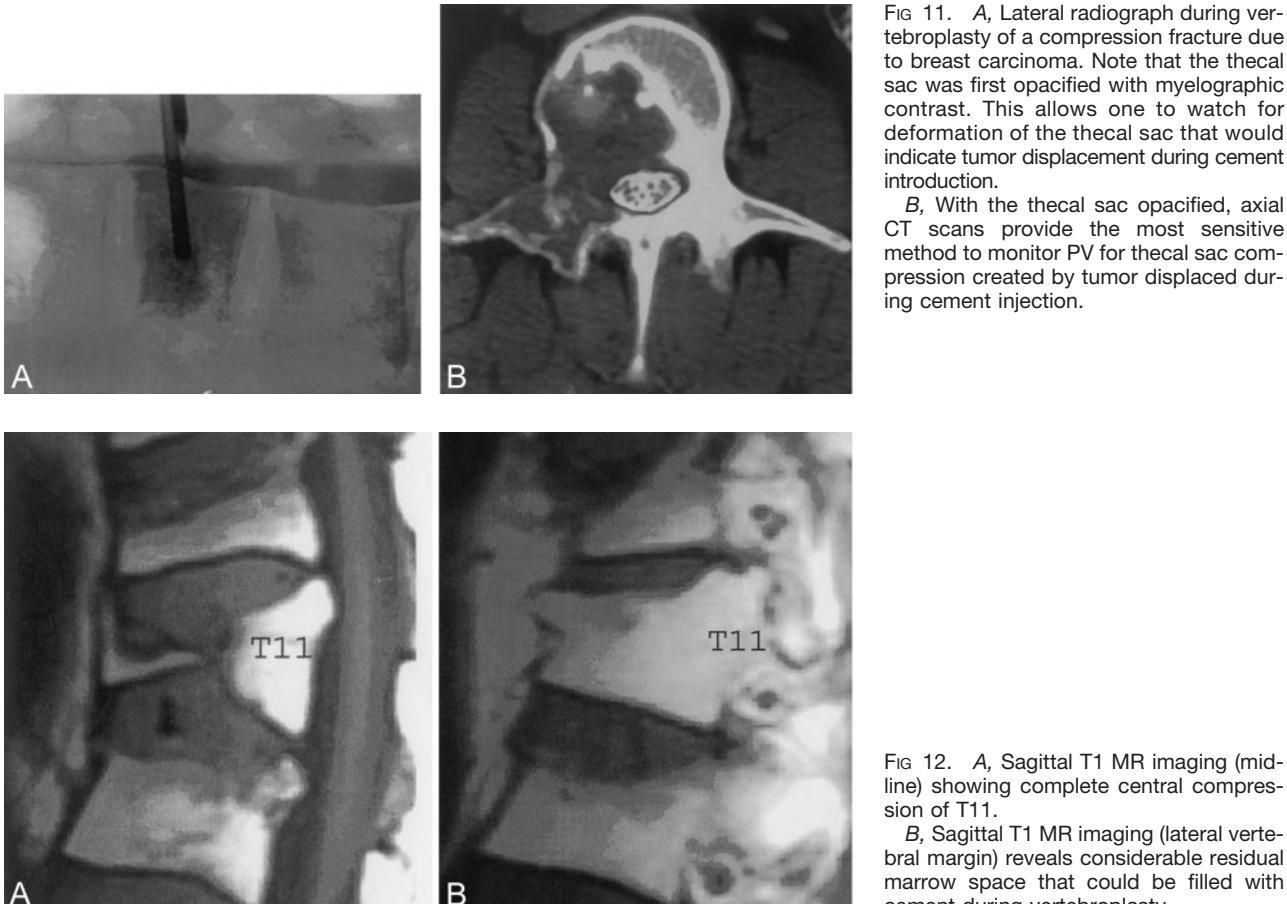
Fig 12. A, Sagittal T1 MR imaging (midline) showing complete central compression of T11.

B, Sagittal T1 MR imaging (lateral vertebral margin) reveals considerable residual marrow space that could be filled with cement during vertebroplasty.

may mark the thecal sac by introducing myelographic contrast before the PV. In the lumbar area it is easy to capture the contrast and still use fluoroscopic guidance during the cement injection (Fig 11A). In the thoracic and cervical areas, however, CT becomes very effective for monitoring the injection and looking for cement or tumor that may be displaced into the canal (Fig 11B). CT does not allow easy real-time

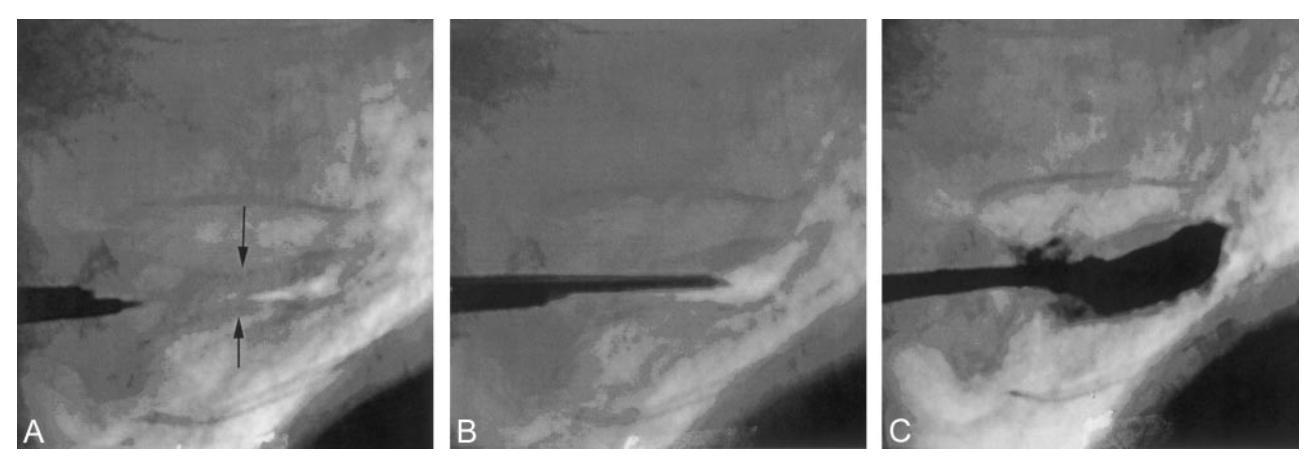
Fig 13. A, Lateral radiograph of an extremely collapsed lower thoracic vertebra. Superior and inferior endplates are identified (black arrows). There is a small air-filled cleft; 13-gauge needles are being introduced via transpedicular route. B, A lateral image showing one 13-gauge needle in good position before vertebroplasty.

C, Final image after bipedicular vertebroplasty. Good filling of the vertebra was achieved despite the severe collapse. The patient had a good pain response to the procedure.

Vertebral Collapse.—Extremely compressed vertebra pose a technical challenge for percutaneous cement augmentation. When compressed more than 75%, just getting a needle into the vertebral body can be difficult; however, we have learned that many of these vertebrae can be treated successfully with PV and produce good pain relief (19, 20). In addition, a vertebra that appears almost completely collapsed may have substantial sparing of its height laterally. This occurs because many vertebrae collapse more in the center than they do along the lateral edges (Fig 12). With care, it is quite common to be able to get a 13-gauge needle system into the lateral aspect of these vertebrae and successfully perform PV (Fig 13). Because of the marked central collapse, a bipedicular approach is useful, because it allows better bilateral vertebral filling. Patients presenting with pain associated with an extreme vertebral collapse should have an attempt at treatment. The amount of cement for this treatment will be smaller than for less compressed vertebra. It is obvious that, because of the challenging technical nature of these compressions, they should not be one's first case. They can, however, present a good opportunity for successful pain relief (20).

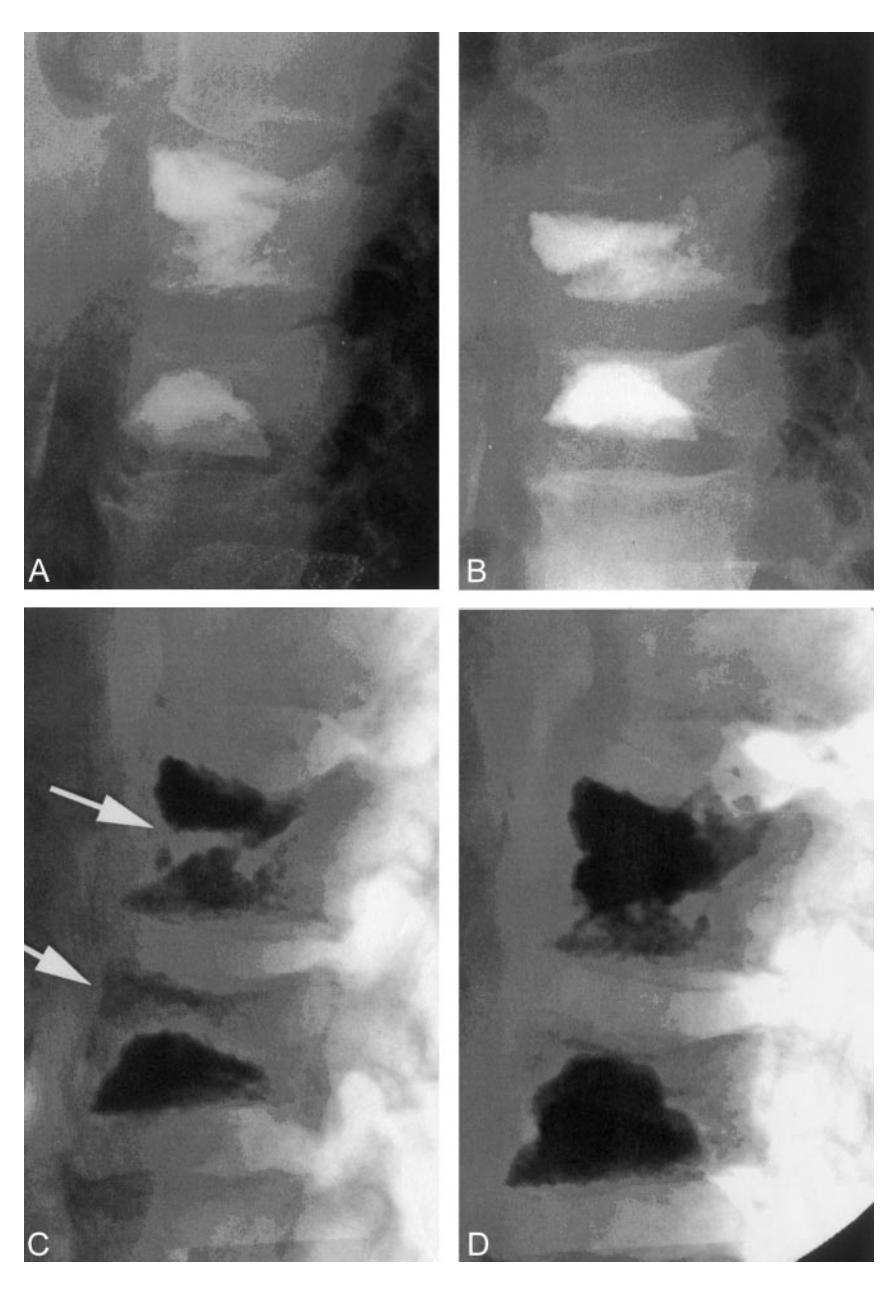
Fig 14. *A*, Lateral radiograph following a two-level vertebroplasty.

B, Follow-up lateral radiograph after refracture of both previously treated levels. Both levels show height loss compared with image shown in panel *A*.

C, With the patient placed in mild extension on the angiographic table, the two vertebrae show height restoration and the development of internal clefts (*white arrows*).

D, The final image following vertebroplasty retreatment. The clefts shown in panel C have been filled with cement. The procedure eliminated the patient's pain, and this fixation has been durable for more than 2 years.

have increased, however, we occasionally see vertebra that refractured after treatment with PV. This may occur when too little cement is injected, resulting in less than optimal biomechanical reinforcement the vertebra. Belkoff et al performed an ex vivo study on osteoporotic cadaver vertebrae, randomized to various injection volumes, to determine the quantity of cement needed to restore the original vertebral strength after fracture. This indicated about 2.5-3.0 mL in the upper thoracic spine, 3.0-4.0 mL in the thoraco-lumbar junction, and 6.0-8.0 mL in the lower lumbar spine (21). We know that pain relief has been poorly correlated (if at all) with the quantity of cement injected. This is not the case with biomechanical reinforcement. Some vertebra prove to be so fragile that even with reasonable amounts of cement injected to produce pain relief, there is still a risk of refracture. Figure 14 shows such a case of refracture and a successful repeat PV. Repeat imaging and physical

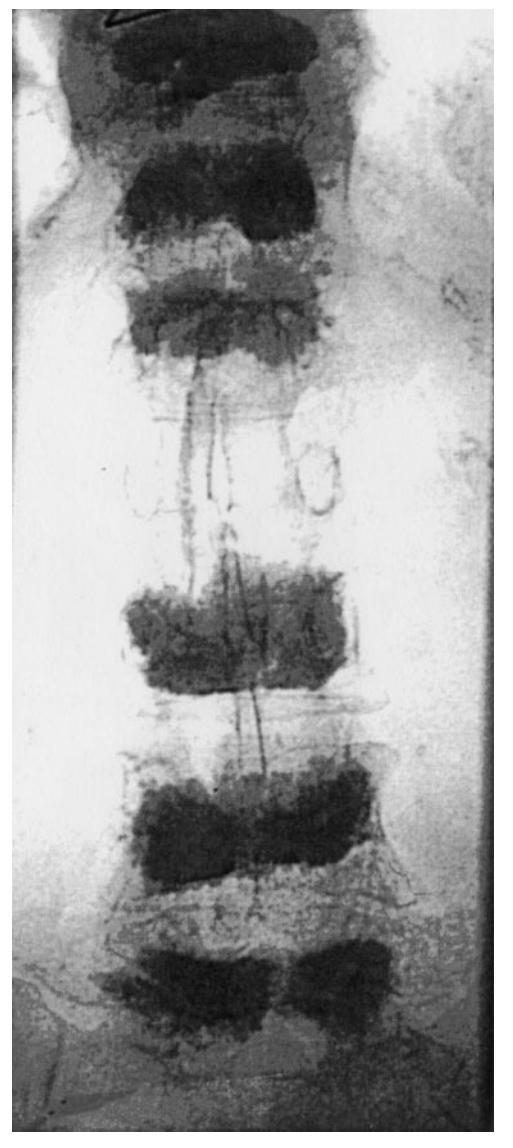
F_{IG} 15. Anterioposterior radiograph showing six vertebrae treated with vertebroplasty. Ultimately, 10 levels were treated in this patient.

Multilevel therapy can be accomplished successfully when approached with caution. Mathis et al reported the first seven-level therapy in 1998 in a 35-year-old lupus patient with multiple compressions secondary to high-dose steroid therapy (22). The treatments were divided, and the patient has had many years without pain or subsequent fracture (with lupus under control and no longer receiving highdose steroids). I have treated as many as ten levels in a single individual with good results but always dividing therapy into multiple sessions (Fig 15). Prophylactic therapy is still avoided.
