## **Vertebroplasty: Cement Leakage into the Disc Increases the Risk of New Fracture of Adjacent Vertebral Body**

Edward P. Lin, Sven Ekholm, Akio Hiwatashi and Per-Lennart Westesson

*AJNR Am J Neuroradiol* 2004, 25 (2) 175-180  
<http://www.ajnr.org/content/25/2/175>

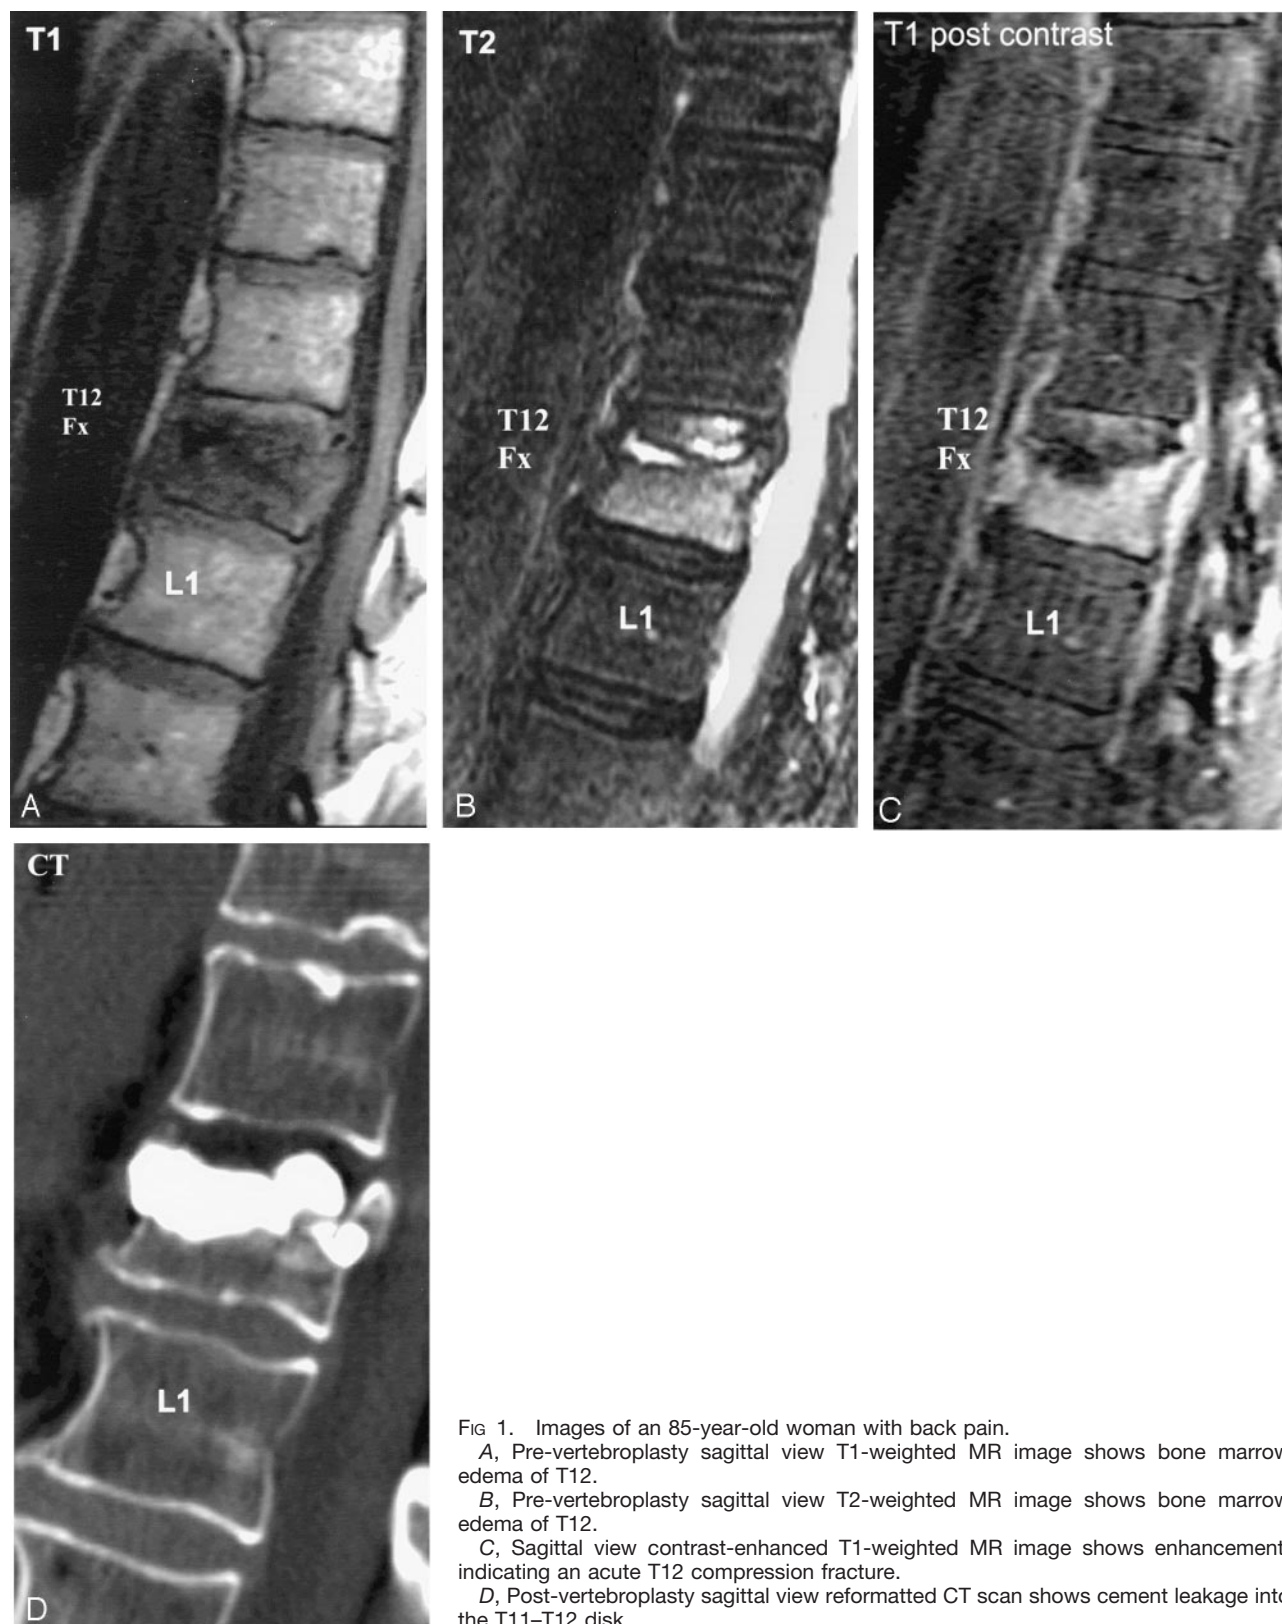
FIG 1. Images of an 85-year-old woman with back pain.

A, Pre-vertebroplasty sagittal view T1-weighted MR image shows bone marrow edema of T12.

B, Pre-vertebroplasty sagittal view T2-weighted MR image shows bone marrow edema of T12.

C, Sagittal view contrast-enhanced T1-weighted MR image shows enhancement, indicating an acute T12 compression fracture.

D, Post-vertebroplasty sagittal view reformatted CT scan shows cement leakage into the T11–T12 disk.

We identified new fractures in 14 of the 38 patients during the follow-up period. Ten patients had new fractures associated with cement leakage into the disk, and four patients had new fractures not associated with cement leakage into the disk (Table 2) (Figs 1 and 2). This difference was statistically significant ( $P = .018$ ).

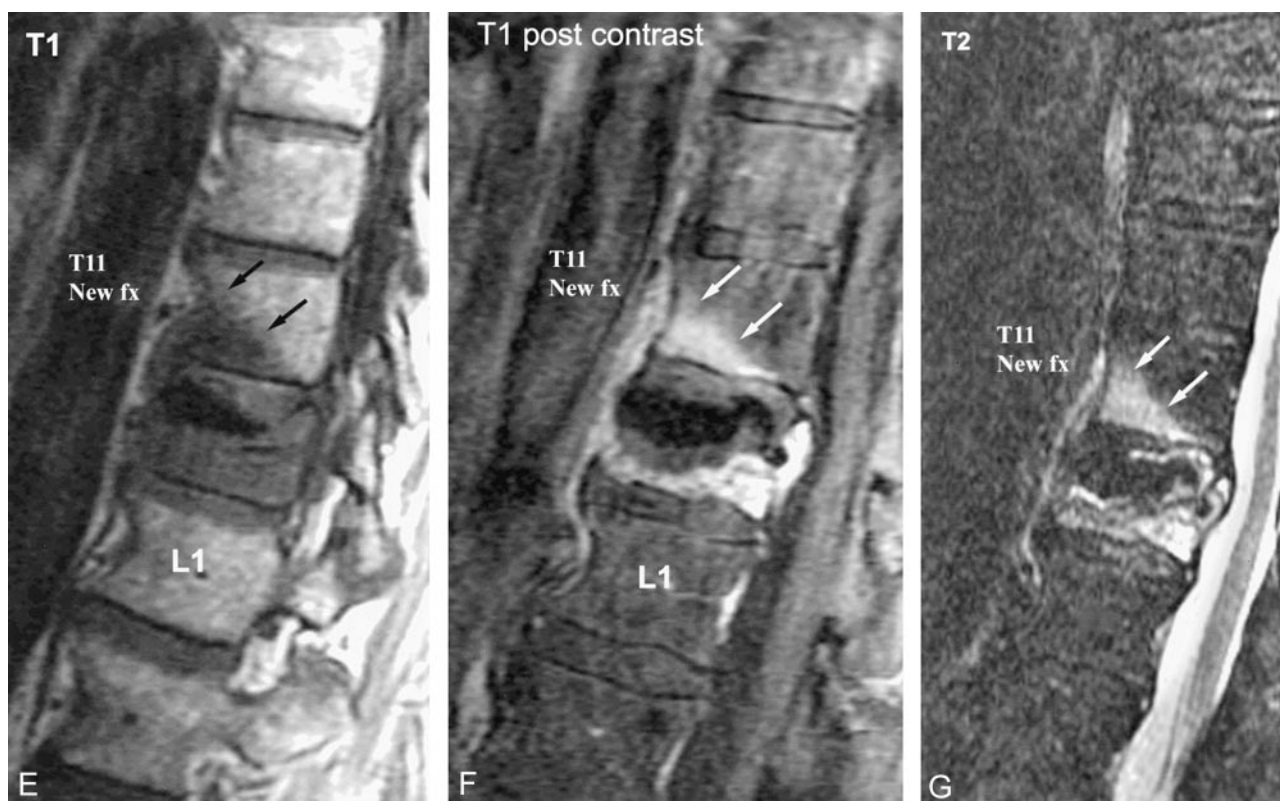
FIG. 1. Continued

E, Sagittal view T1-weighted MR image obtained 15 days later, when the patient returned with new pain, shows new bone marrow edema of T11.

F, Sagittal view T2-weighted MR image obtained 15 days later, when the patient returned with new pain, shows new bone marrow edema of T11.

G, Contrast-enhanced sagittal view T1-weighted MR image shows T11 enhancement, indicating a new acute T11 fracture.

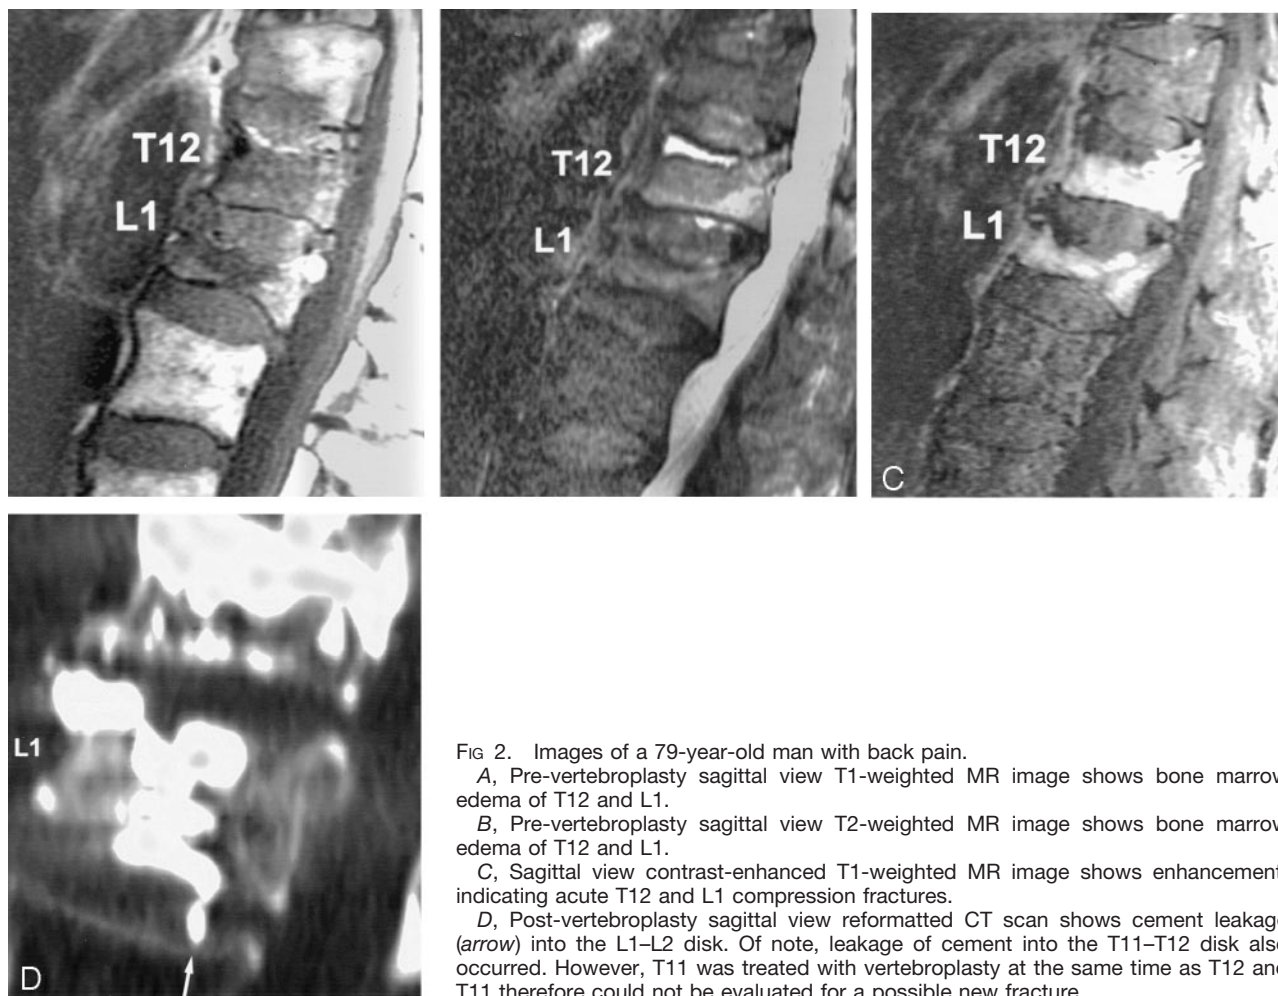
FIG 2. Images of a 79-year-old man with back pain.

A, Pre-vertebroplasty sagittal view T1-weighted MR image shows bone marrow edema of T12 and L1.

B, Pre-vertebroplasty sagittal view T2-weighted MR image shows bone marrow edema of T12 and L1.

C, Sagittal view contrast-enhanced T1-weighted MR image shows enhancement, indicating acute T12 and L1 compression fractures.

D, Post-vertebroplasty sagittal view reformatted CT scan shows cement leakage (arrow) into the L1-L2 disk. Of note, leakage of cement into the T11-T12 disk also occurred. However, T11 was treated with vertebroplasty at the same time as T12 and T11 therefore could not be evaluated for a possible new fracture.

We think that the mechanism for the new fractures is a combination of the underlying condition, mainly osteoporosis or neoplastic disease, and the hard cement in the disk. In eight of the 11 cases, the new fracture was immediately adjacent to the cement in the disk (Fig 2). The immediate adjacency of the cement and the new fracture is a strong indication that the hard cement results in an increased mechanical pressure, eventually causing a new fracture of the endplate in the adjacent vertebral body (Fig 2). The increased mechanical pressure is especially pertinent for patients who increase their daily physical activities as their back pain decreases after vertebroplasty, placing additional stress on the vertebral bodies.

For example, as shown in Figure 2, cement leaked into the L1–L2 disk during vertebroplasty of L1 and later caused a fracture of L2 inferiorly. The MR images obtained when the patient returned with new pain showed bone marrow edema and contrast enhancement. These abnormalities indicated a new fracture. The edema of the superior endplate was thought to be caused by the direct pressure of the hard cement. Edema of the lower half of the L2 vertebral body was also present. This was probably caused by a more generalized compression fracture of L2.

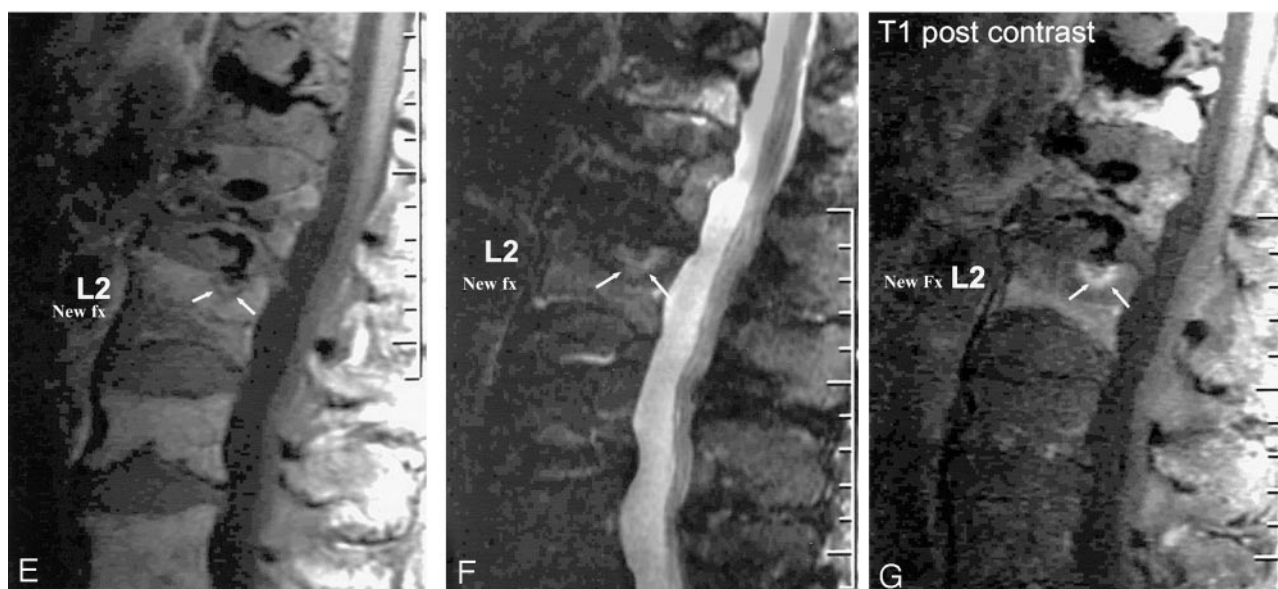
FIG 2. Continued

E, Sagittal view T1-weighted MR image obtained 25 days later, when the patient returned with new pain, shows a focal area of new bone marrow edema of L2 (arrows).

F, Sagittal view T2-weighted MR image obtained 25 days later, when the patient returned with new pain, shows a focal area of new bone marrow edema of L2 (arrows).

G, Contrast-enhanced sagittal view T1-weighted MR image shows enhancement, indicating a new acute focal fracture of L2 superiorly. The new fracture (arrows) is located immediately adjacent to the cement leakage into the disk.
